DOCKING REPORT MANUAL

Guide To Fouling Organisms and Instructions Regarding The Docking Report

Bureau of Ships
Navy Department
Washington, D. C.

1942

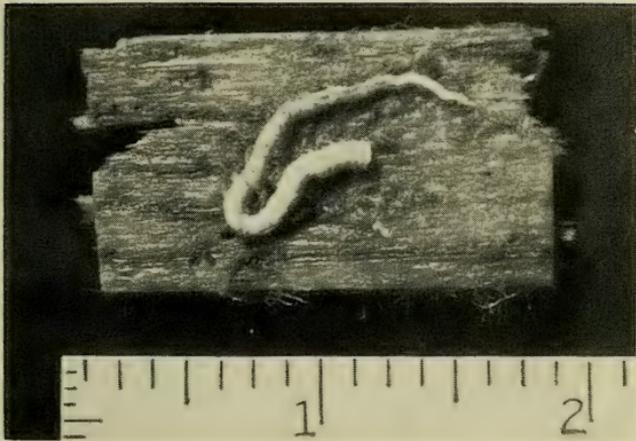
Fig. 1. Annelid.

These organisms can be readily recognized by their hard tubular shells (figs. 1 and 13), each of which houses a living worm. Sometimes the whole shell adheres firmly to the hull, but it may rise from the surface and stand out at a sharp angle. These tubes range in length from a fraction of an inch to several inches, and may form a large proportion of the fouling, especially on ships which have been stationed in the Hawaiian Islands or the southern Pacific. Some of the commonest forms have the scientific name of *Hydroides*. This should not be confused with Hydroids, the common name of an entirely different group of animals.

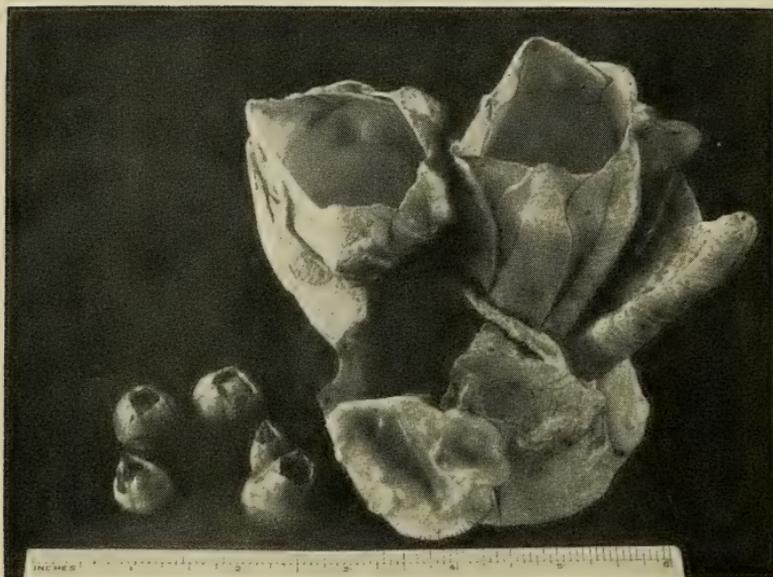
Fig. 2. Acorn Barnacles.

In many waters, Barnacles are the predominant form of fouling. Two general types are found. Acorn Barnacles (figs. 2 and 18) have a hard, conical shell which is made up of several distinct plates, and varies from a fraction of an inch to several inches in diameter at the base. The top of this cone is covered by four movable plates which may become detached when the animal dies. When the whole cone drops off or is re-

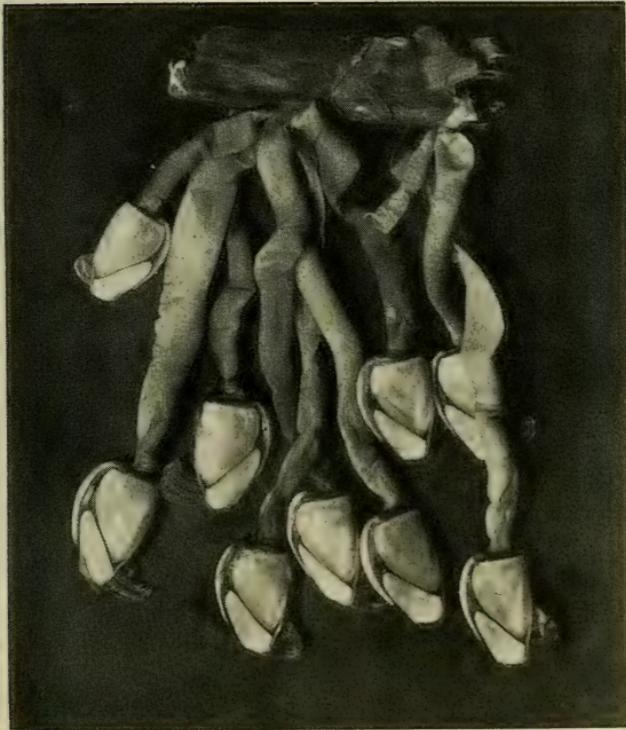
Fig. 3. Stalked Barnacles.

The other type of Barnacle is the Stalked or Gooseneck Barnacle (fig. 3). Whereas Acorn Barnacles are attached to the hull by the calcareous plates which form the cone-shaped shell, Stalked Barnacles have a muscular stalk which suspends the body from the hull. The body proper of both types is always protected by limy plates.

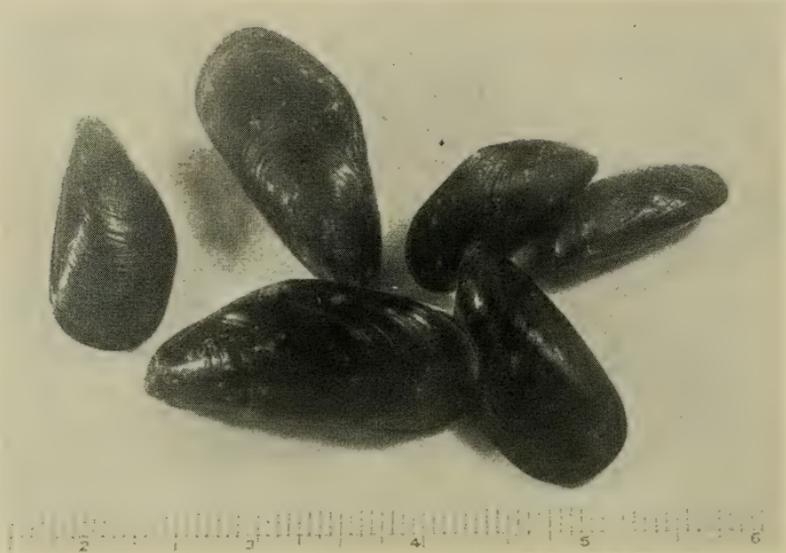
Fig. 4. Mussels (Mollusks).

This group includes the familiar edible clams, oysters, and mussels (fig. 4). All of the forms important in fouling are characterized by having paired or "two-valved" shells. They are generally attached to the hull at the region of the hinge of this double shell. Very many shapes are found, but all are characterized by this paired hinged shell, a structure not found in any other group of fouling organisms. Mollusks may grow to a large size, and since they may become attached to other Mollusks which in turn are attached to the hull, they frequently build up a large bulky mass of fouling.

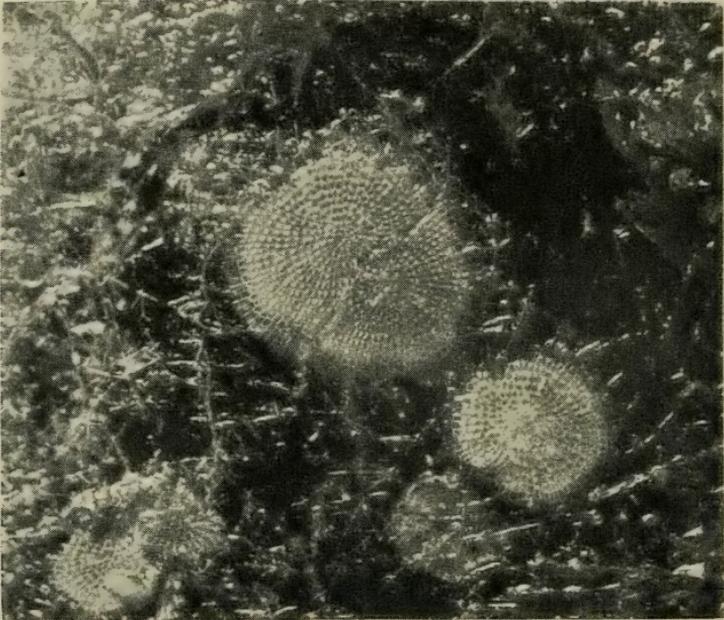
Fig. 6. Bryozoa (coral patches).

(fig. 6). When an adult Barnacle falls off the hull it generally leaves behind a circular patch or base plate. This may resemble a coral patch. The base plate of the Barnacle is marked by lines, whereas the coral patch is distinctly granular in appearance. The flat encrusting type of Bryozoa is frequently hard and calcareous, whereas the branching type is generally soft and flexible.

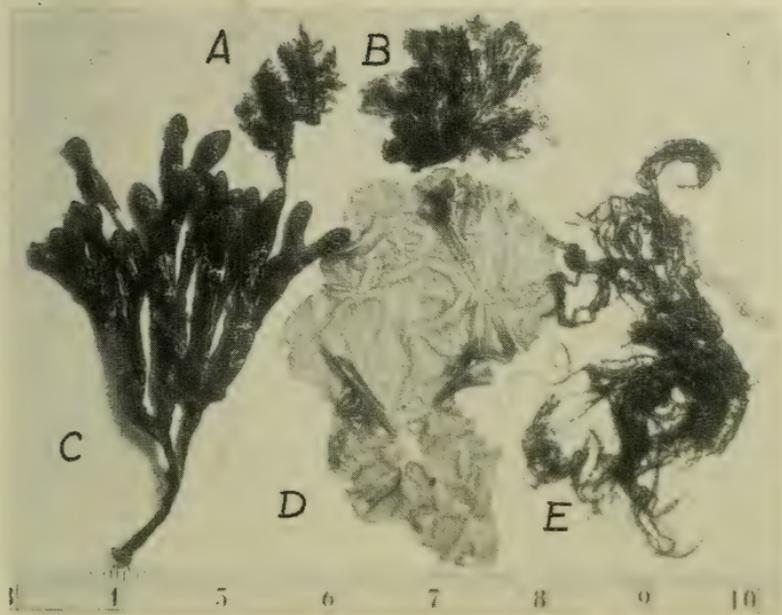
Fig. 7. Algae.

A, D, E, green algae; B, a red alga; C, a brown alga.

The characteristic fouling forms consist of mats of long slender threads or filaments, usually branched (fig. 7, A, B, and E). Others have fronds resembling ribbons or leaves of lettuce (fig. 7, D), and still others (known as rock-weeds) have hollow swellings which serve as floats (fig. 7, C).

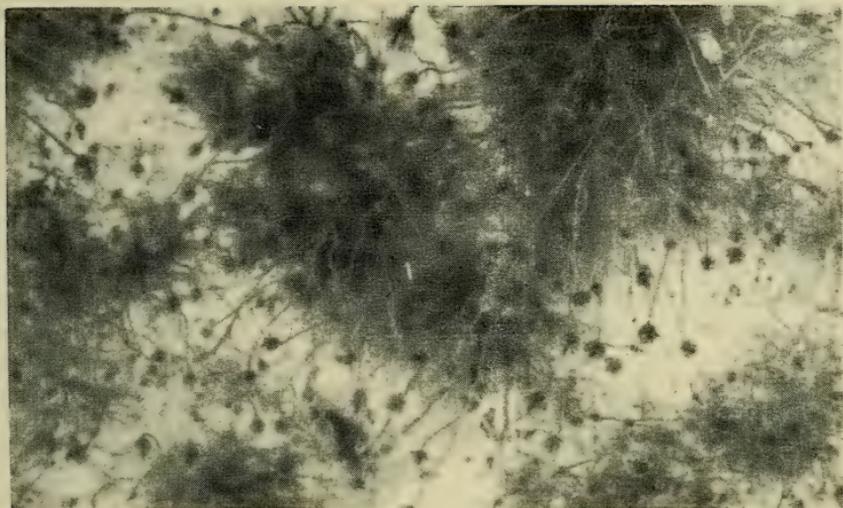
Fig. 8. Hydroids, attached to a panel, normal size.

Hydroids (figs. 8 and 9) are small animals with slender stalks. Joined together like Siamese twins, they usually live in plantlike colonies composed of many individuals. Each branch of a colony represents a single individual. At the end of each branch is a flowerlike expansion, frequently pink in color. These expansions readily distinguish Hydroids from the branching types of Bryozoa. When attached to a hull, Hydroids often form a pale cream or tan mat which may be very thick and extensive.

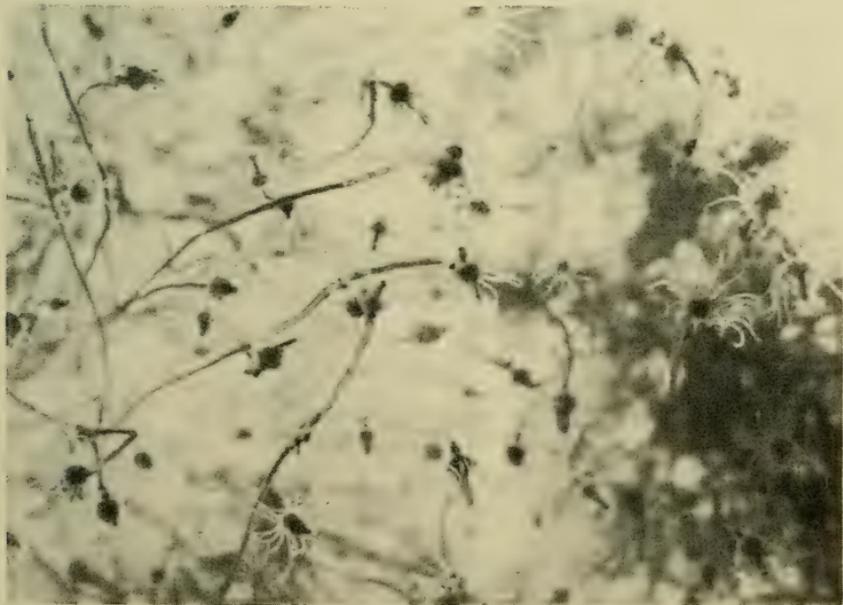
Fig. 9. Hydroids, enlarged.

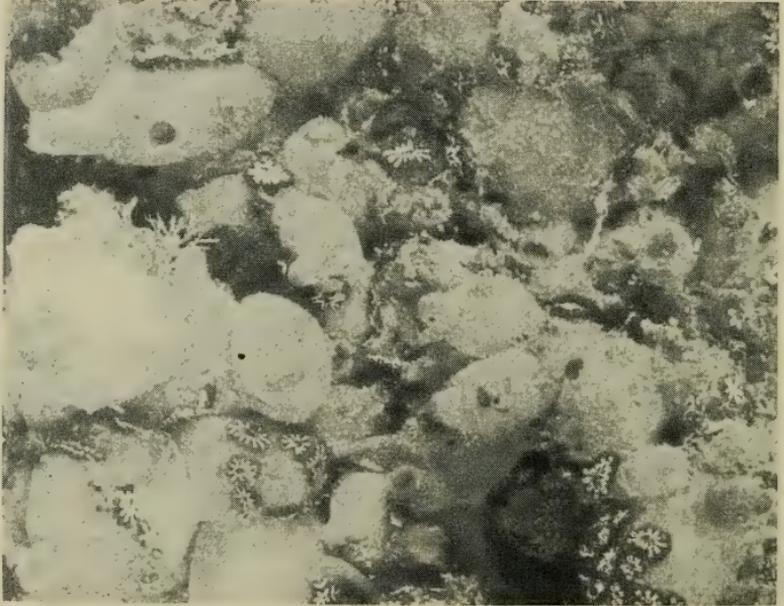
Fig. 10. Tunicates photographed under water.

Tunicates are soft-bodied, more or less leathery animals of various irregular shapes, often with a translucent covering (figs. 10 and 11). Each individual has two openings, one used as the intake and the other as the discharge for the sea water from which they sift their food, but as some kinds are colonial, a single mass may have more than one pair of holes. From their habit of expelling sea water, sometimes from both openings at once, these animals have also received the name of sea squirts.

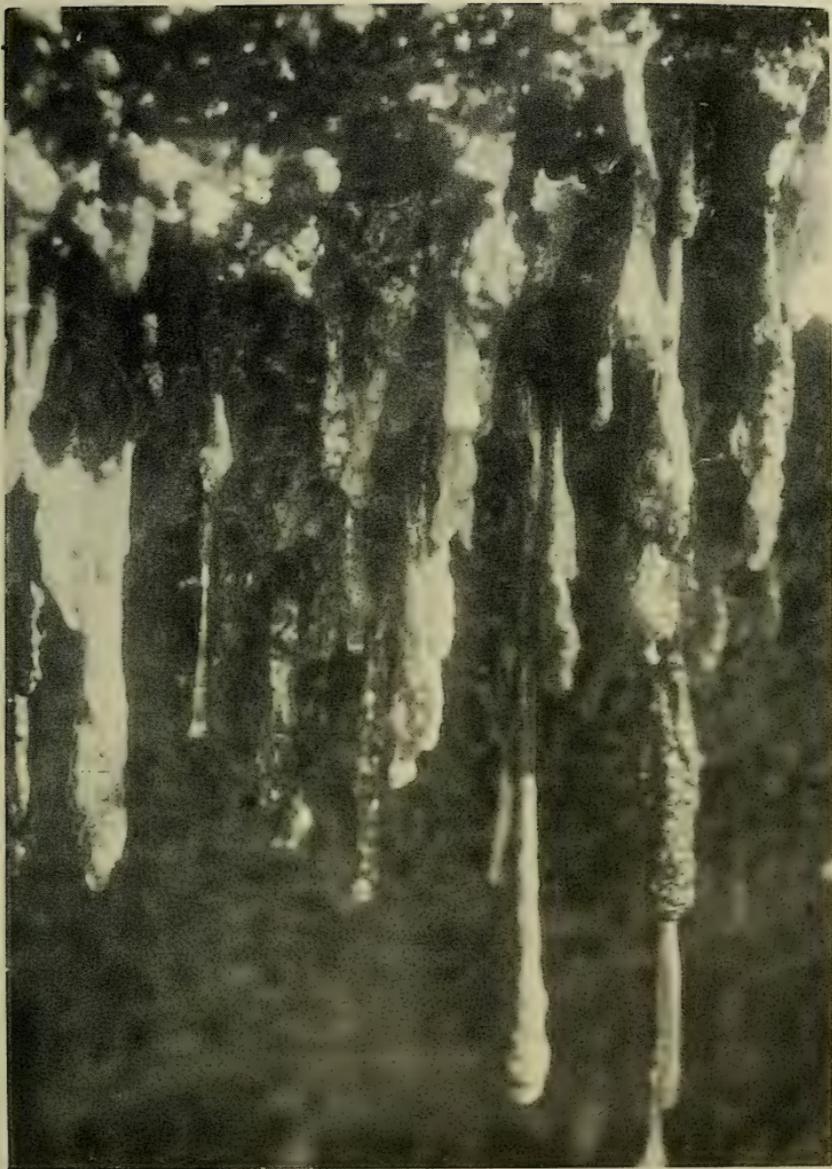
Fig. 11. Tunicates on an exposed hull.

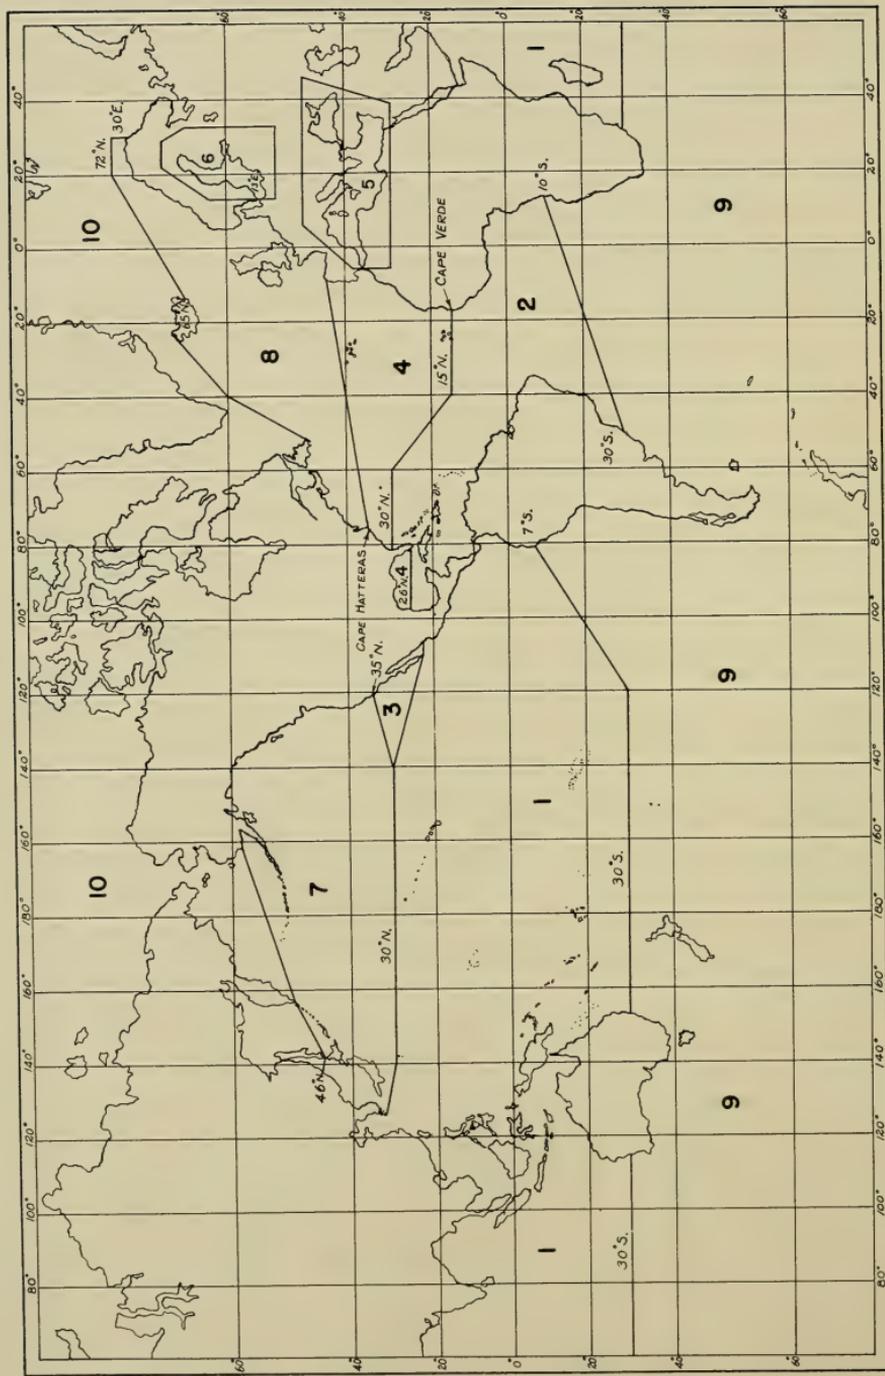
Fig. 12. Areas of different fouling conditions.

tive features in regard to fouling. These regions are numbered in approximately the order of their relative severity.

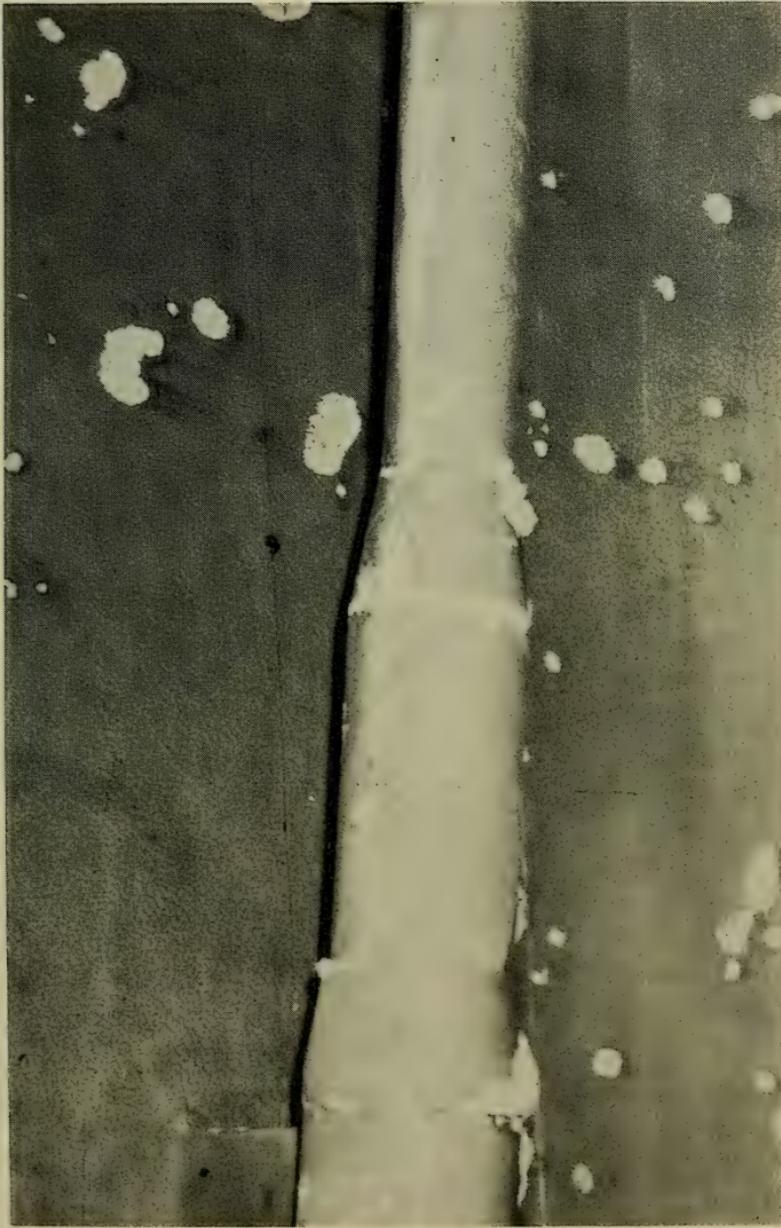
Fig. 13. Fouling in isolated small spots (note clusters of Annelids, common on ships stationed in tropical Pacific).

To aid in judging the extent of fouling, photographs showing all but "negligible" fouling are reproduced as figures 13-16. The grades established by these photographs may seem rather severe, but it should be emphasized that *any* fouling in a given area represents a partial failure of the paint. The percentage of film area that is ineffective is more important than the total weight or thickness of the fouling.

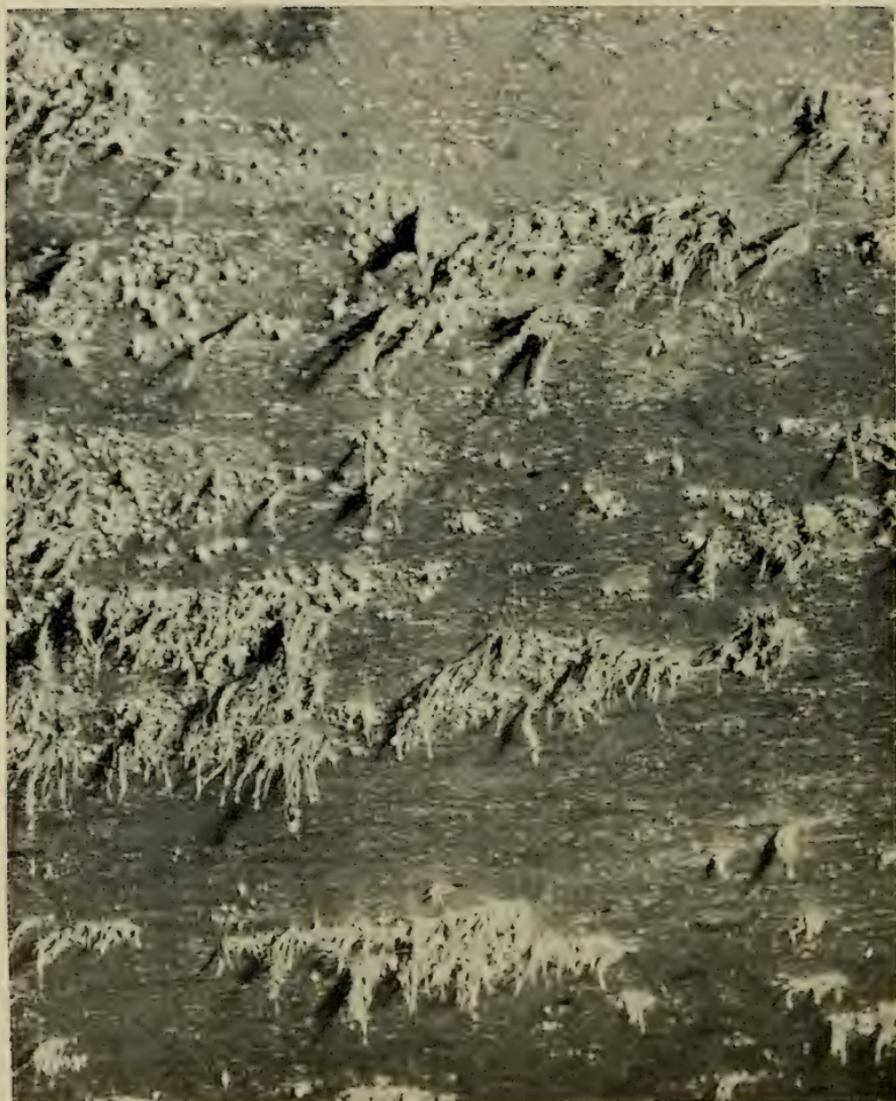
Fig. 14. Fouling (mostly Hydroids) in large patches.

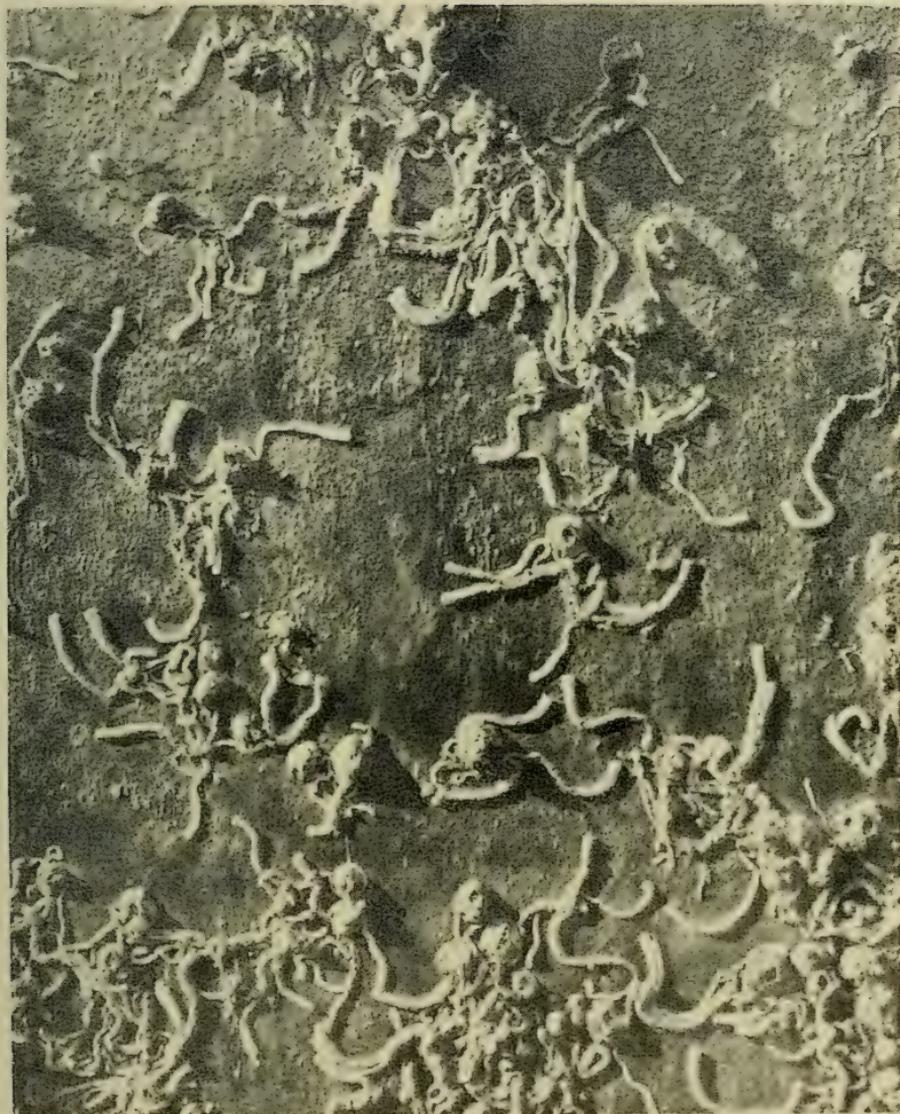
Fig. 17. Fouling organisms (Annelids and Barnacles) uniformly distributed. Corresponding to fouling distributed in large patches.

PERCENTAGE OF GIVEN AREA UNIFORMLY FOULED	CORRESPONDING GRADE OF "PATCHY" FOULING
0-5%	"negligible"
5-10%	"in isolated small spots"
10-20% (fig. 17)	"in large patches"
20-50% (fig. 18)	"covering larger part of area"
50-100%	"covering area completely"

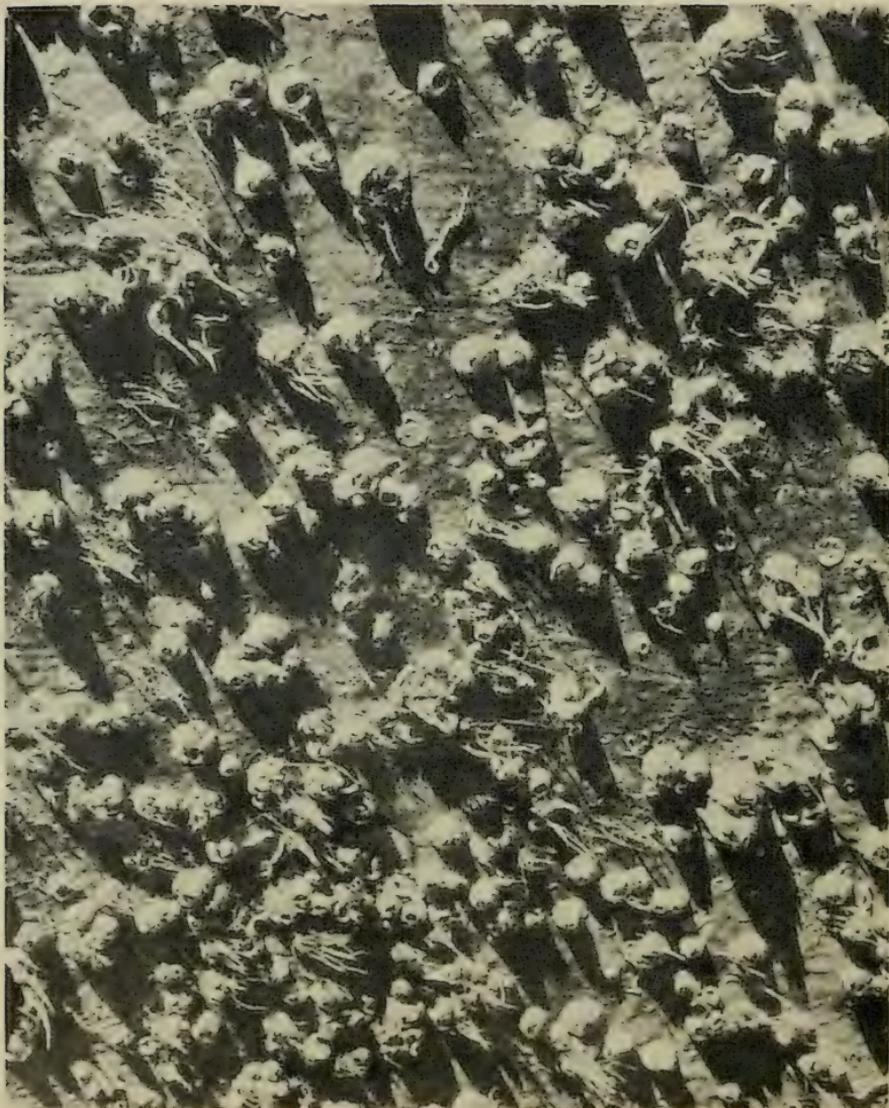
Fig. 18. Fouling organisms (Barnacles with Bryozoa and Annelids) uniformly distributed. Corresponding to fouling covering larger part of area.

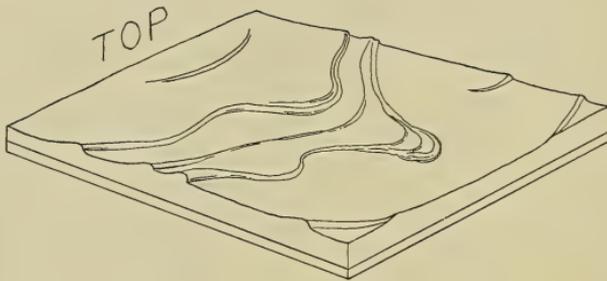
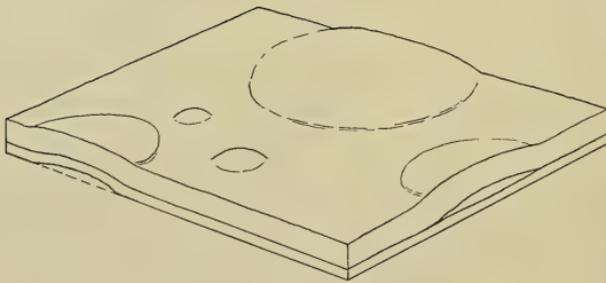
Fig. 19. Types of paint failure.

SAGGING

BLISTERING

⑯ Submit photographs of special or unusual conditions if possible. See figs. 19-20.

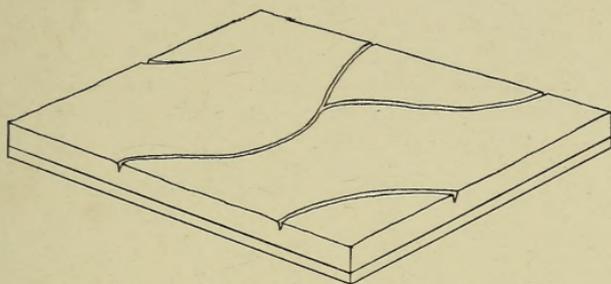
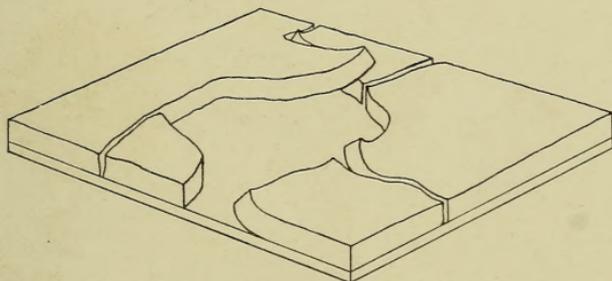
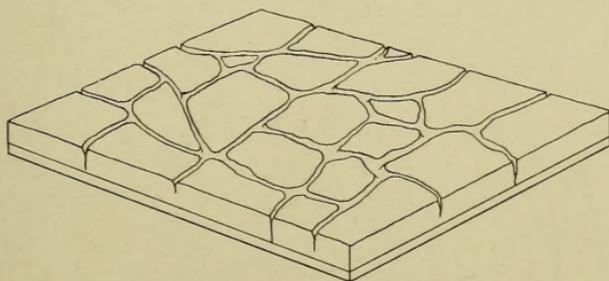
Fig. 20. Types of paint failure.

CHECKING (*surface cracking*)

CRACKING and PEELING

ALLIGATORING
